Catastrophic Full Thickness Wear of Oxinium Knee Implants: A Case Report and Analysis of Failure Mechanisms

- Rajesh Malhotra, MS
 Orthopaedics, FIMSA, FRCS,
 FACS*
- 2. Naman Wahal, MBBS, MS Orthopaedics*

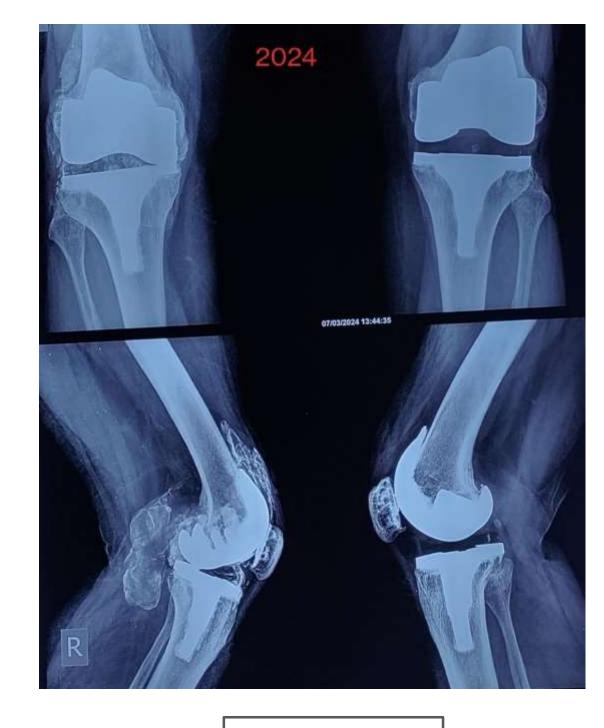
Sequential Xrays

- 63-year-old female,
- 9 years post bilateral knee arthroplasty with oxinium implants.
- Symptoms: Progressive right knee pain and instability starting 2 years post-surgery.
- Radiographs: Medial joint space narrowing and metal debris suggestive of metallosis

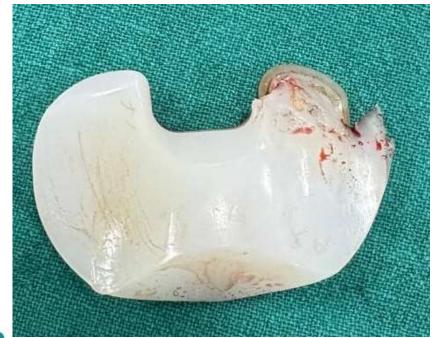
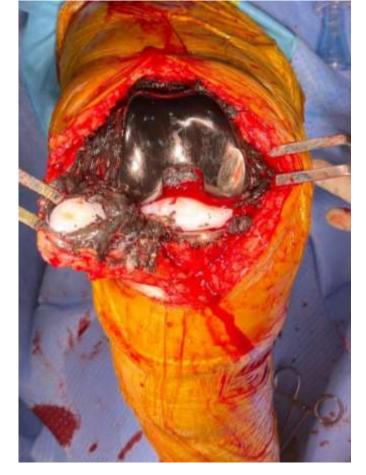
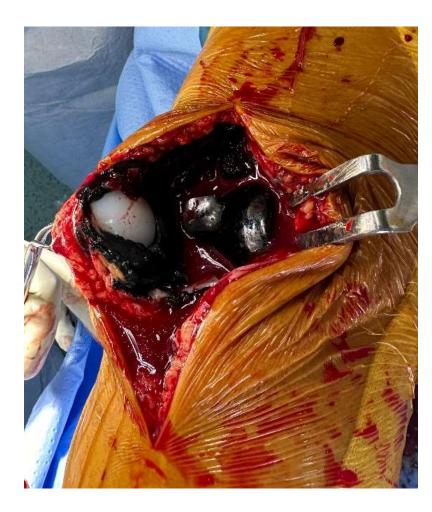
Intraoperative Findings

- Complete polyethylene wear on postero-medial aspect.
- Scratched oxinium surface.
- Black metallosis throughout joint.

- 1. Polyethylene Wear:
 - Led to metal-on-metal articulation
- 2. Edge Loading:
 - Scratched the oxinium surface
 - Exposed softer zirconium core
- 3. Metallosis:
 - Triggered inflammation, causing synovitis and bone loss
- 4. Surgical Technique and Implant Design:
 - Possible improper polyethylene seating.
 - Unbalanced gaps contributed to early failure

- LCCK-like implant used with distal and posterior femoral augments
- All visible metallosis debrided except posterior recess
- Patient allowed full weight bearing from day 1
- At 6 months: 0-70° ROM, no pain or instability
- At 1 year: 0-80° active ROM, 0-110 ° passive ROM, no pain or instability
