Catastrophic Full Thickness Wear of Oxinium Knee Implants: A Case Report and Analysis of Failure Mechanisms

- Rajesh Malhotra, MS
 Orthopaedics, FIMSA, FRCS,
 FACS*
- 2. Naman Wahal, MBBS, MS Orthopaedics*

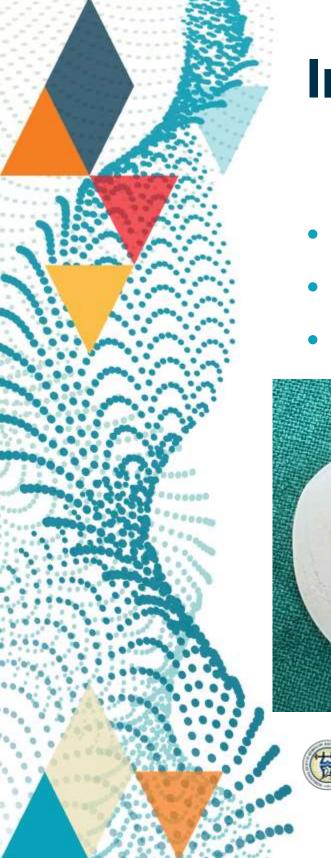
Intraoperative Findings

- Complete polyethylene wear on postero-medial aspect.
- Scratched oxinium surface.
- Black metallosis throughout joint.
